2020 Amendment #1 to Water System Preliminary Engineering Report

City of David City, Nebraska
October 2020

JEO Project #200941.00

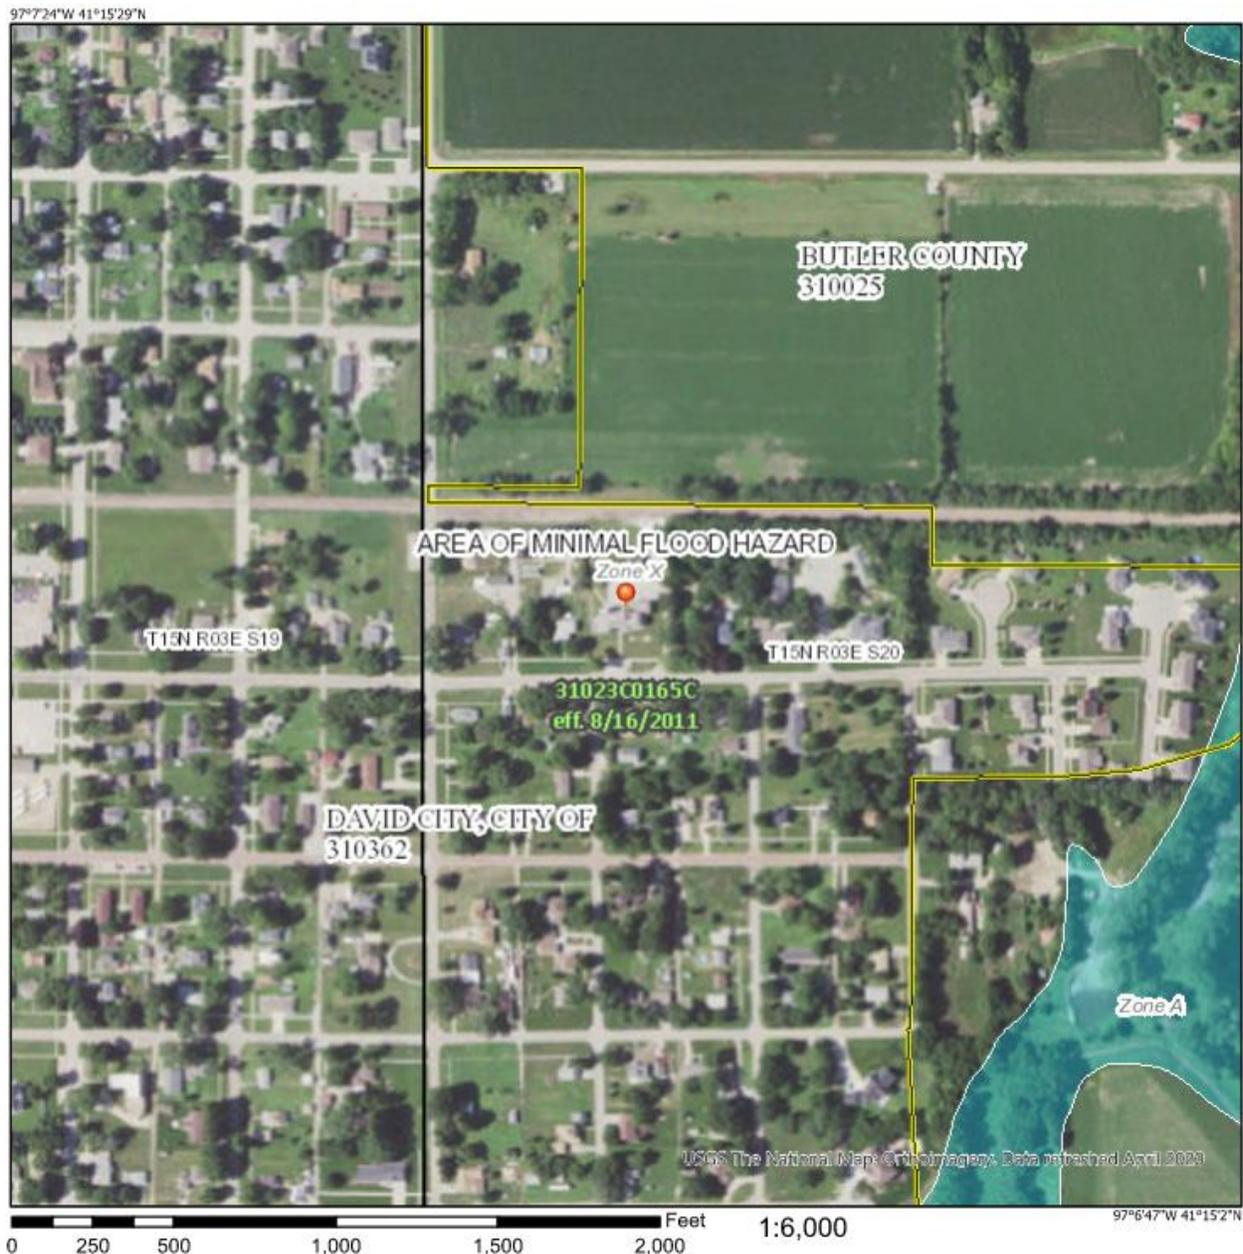
Figure 1-2: City of David City FIRM

A FEMA designated floodplain map for the portion of the community near the existing water treatment plant is included below in **Figure 1-2: City of David City FIRM**. As can be seen, the existing water plant is not located in any mapped floodplain area.

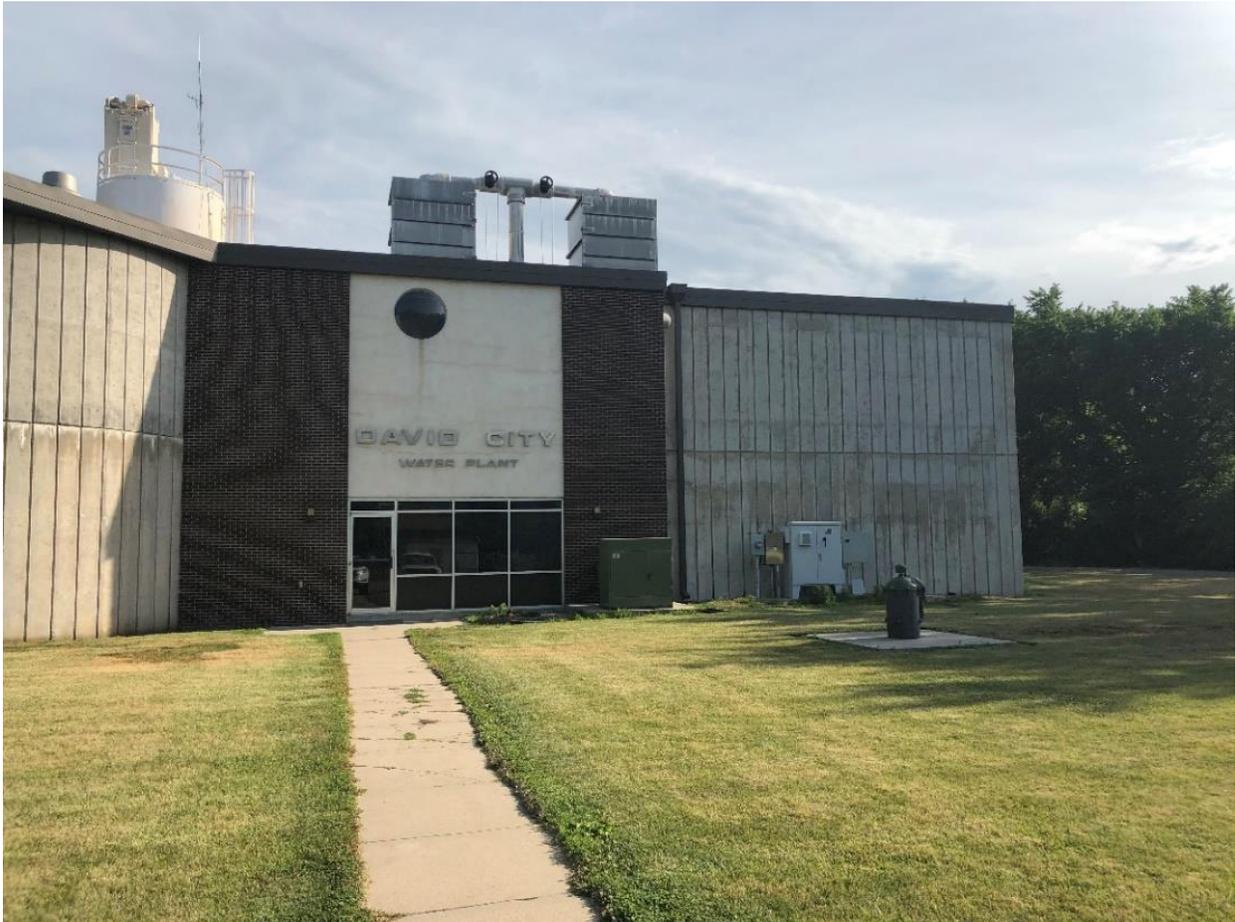
Figure 2-8: Water Treatment Plant Exterior

A picture of the exterior of the water plant can be seen in the following figures. These figures are provided to give an idea of the current condition of the treatment plant. The overall exterior condition is fair with some minor cracking and spalling of the pre-cast concrete exterior especially around the Solids Contact Unit (SCU). Repair and waterproofing of this area is recommended to prolong its lifespan.

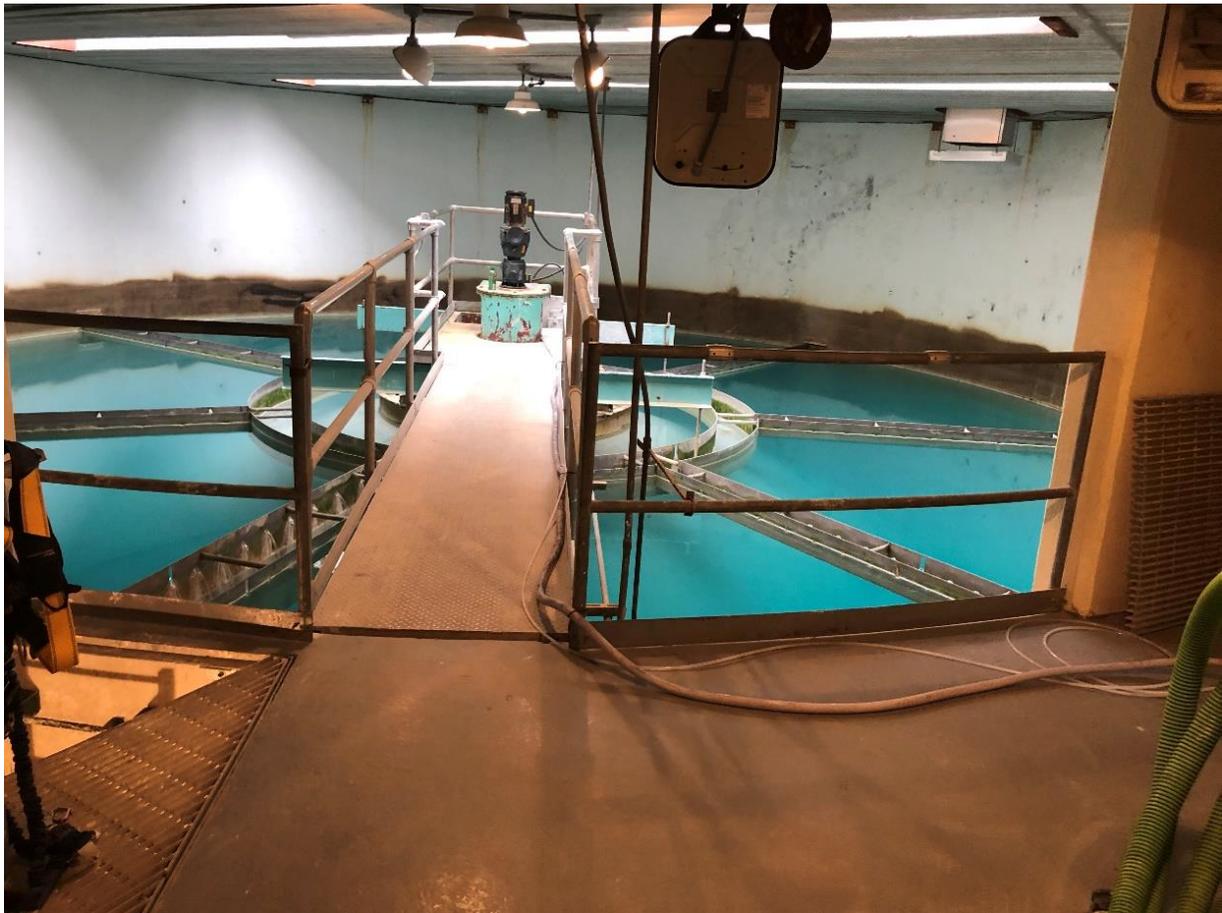
Figure 2-11 Existing Solids Contact Unit

Figure 2-11: Existing Solids Contact Unit presents a photo of the existing solids contact unit within the WTP. The diameter of the existing concrete tank is approximately 40' with a side water depth of 18.25'. The unit is rated for a flow of 1,800 gpm with a surface overflow rate of 1.75 gpm/ft².

Given that the basin is a single unit, no redundancy is provided. This has caused issues for the city in the past when maintenance or failures of the unit has occurred. Other noted concerns are corrosion to the steel structure and overall age of the unit. Operation in a high pH environment when lime is added to water is very hard on steel. Operational staff note that the existing unit has failures of the painting system and is need of major rehabilitation. It is recommended that complete replacement of the unit is performed if this is to be kept in service. Replacement units can be stainless steel or painted steel. The existing area roof will have to be removed in order to accomplish the replacement. Further discussion of improvement alternatives is found in later sections of this report.

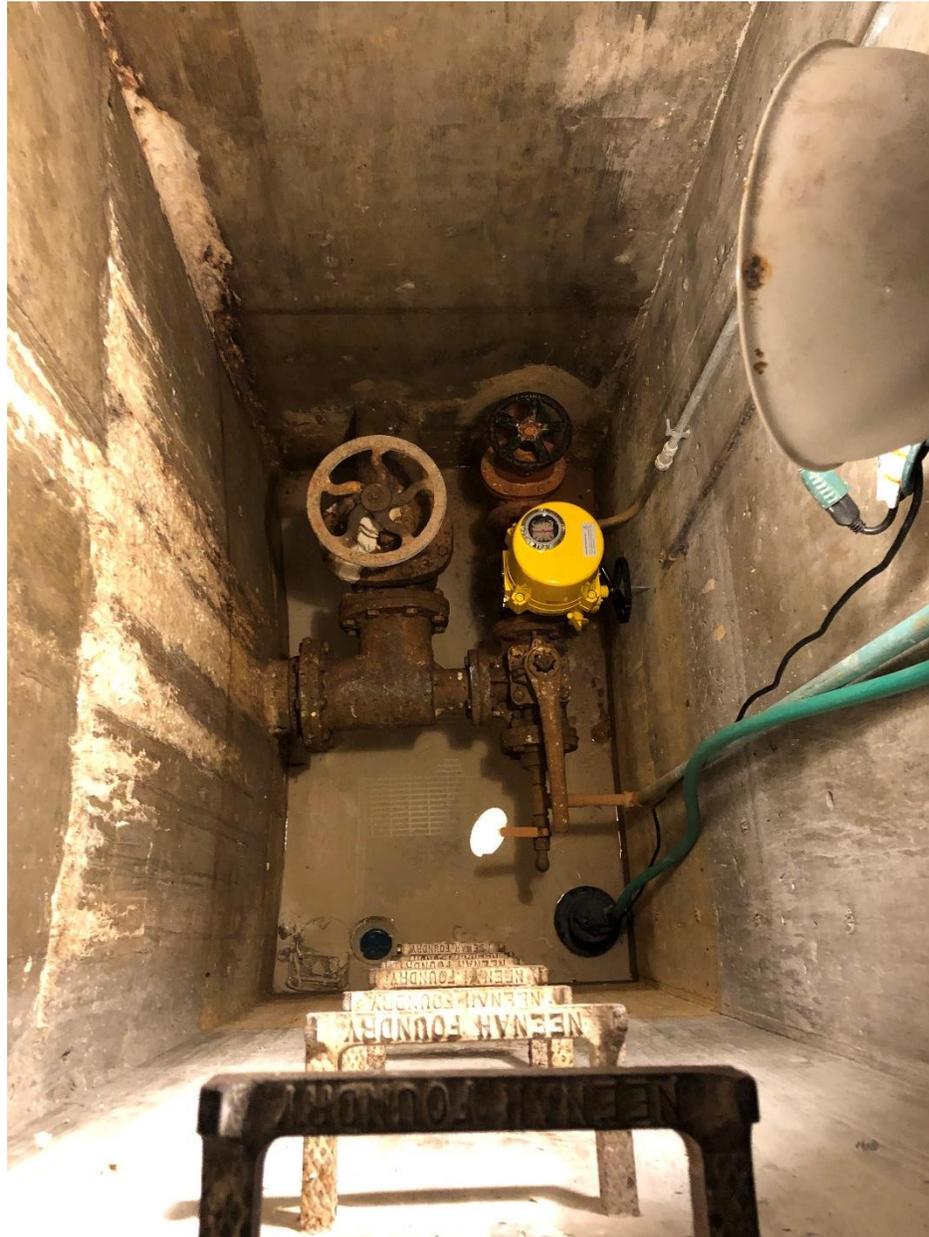
Figure 2-13: SCU Sludge Valve Pit

frequently become plugged and the actuator is not reliable and failures of valves in the past causes leaks and flooding of a normally dry area. It is recommended to reconfigure the existing valving to utilize a single, 6" actuated valve and provide a backflush system that flushes clean water backwards through the sludge line to limit any plugging and operational issues. The following figure illustrates the sludge valve pit.

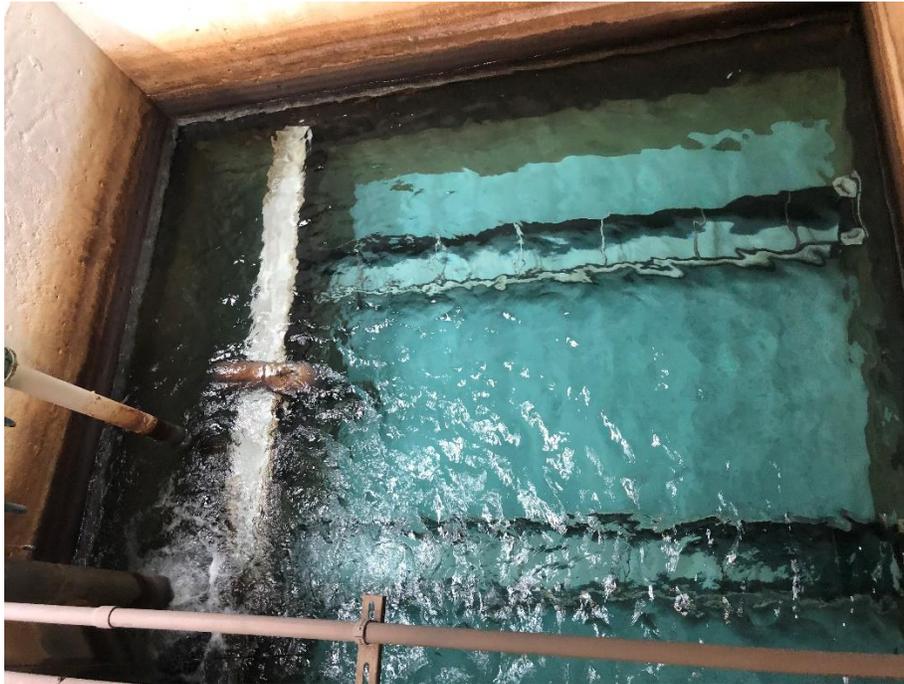
Figure 2-15: Gravity Media Filter Cell

After recarbonation, water overflows by gravity into dual-media gravity filters. The existing gravity filter unit serving the City consists of four-cells, with a total filter area of 700 ft² (14' x 12.5' each). At the design filtering rate of 2.60 gal/min-ft², the unit has a capacity of approximately 1,800 gpm. The original filters were manufactured by General Filter in Ames, IA (now owned by WesTech in Salt Lake City, UT). **Figure 2-15: Gravity Media Filter Cell** presents a photo of one of the filters.

The filters consist of 18" of anthracite media (0.6 to 0.8 mm), 12" of sand (0.5 to 0.6 mm), and support gravel. According to available information, the filter media was last replaced in 2006 with filter sand (0.45 to 0.55 mm) and anthracite (0.9 to 1.0 mm). The underdrains are reported to have been replaced in 2006. The original fiberglass wash troughs are still in use.

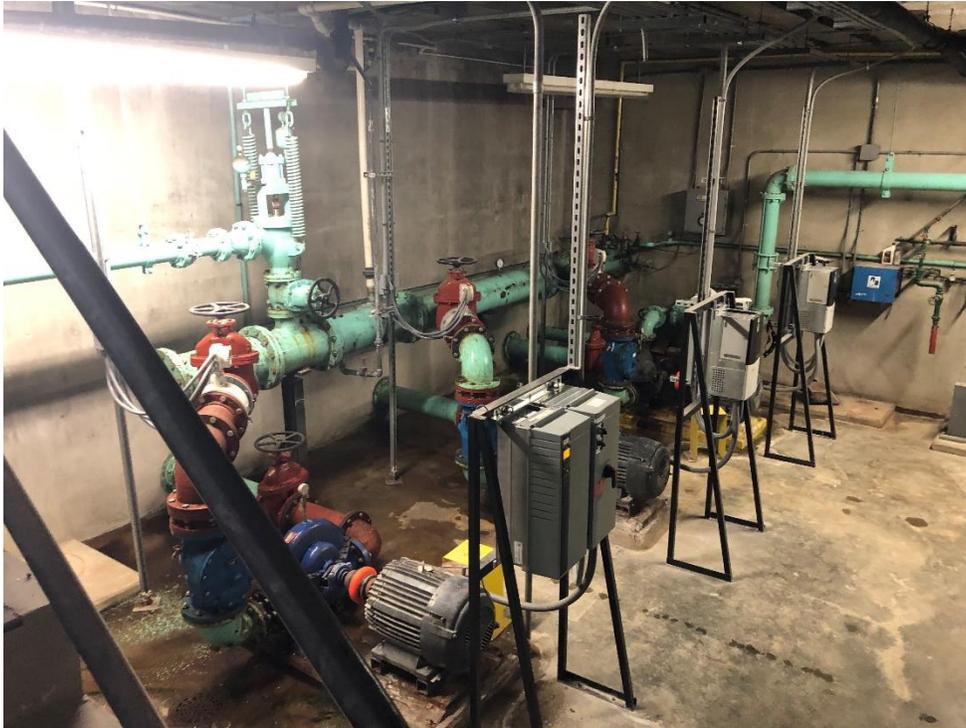
Figure 2-16: Water Treatment Plant High Service Pumps

The high service pumping station at the WTP consists of three (3) high service pumps. These pumps were replaced in 2010 and have Variable Frequency Drives (VFDs) installed on each pump. All three pumps have a capacity of 875 gpm. The pumps are reported to be in good condition. However,

minor valve replacements, painting of existing piping, and potential relocation of the VFD's to a better location are recommended.

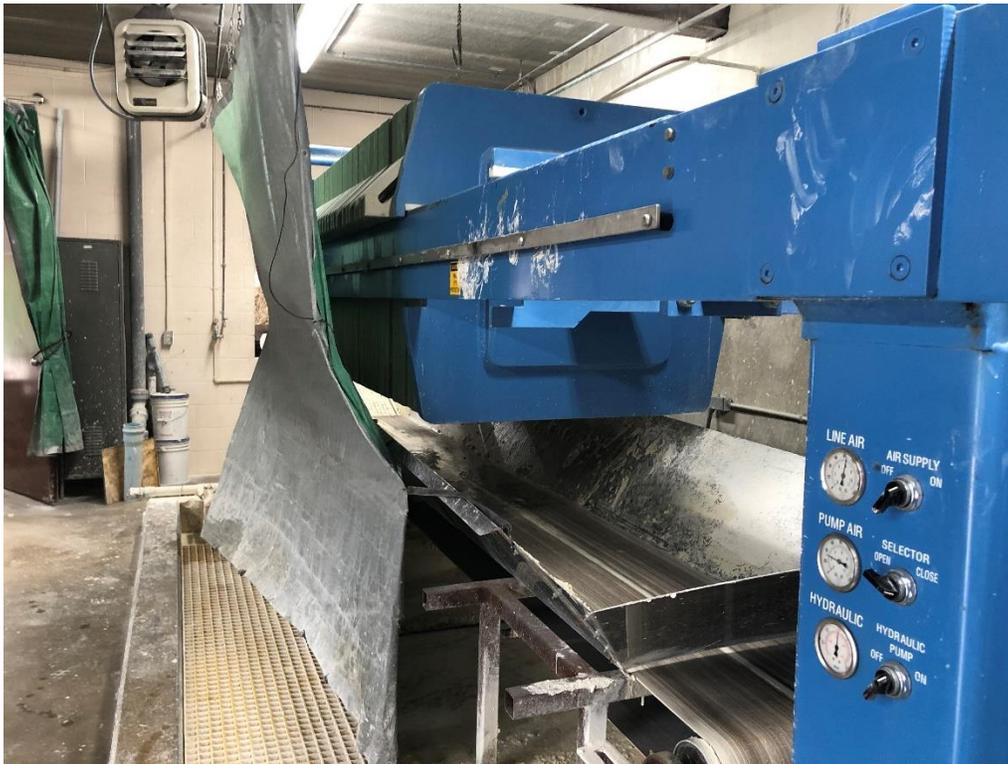
Figure 2-17: Sludge Belt Filter and Conveyor

The settled sludge is drained out of the bottom of the SCU via a 6" or 3" pipe to the sludge valve and collection pit. Decanted water from the pit is directed to the backwash holding tank as previously indicated. The settled sludge is then pumped via a diaphragm pump to a sludge plate press and conveyor, then hauled off site. **Figure 2-17: Sludge Belt Filter and Conveyor** presents a photo of the plate press and conveyor used for the lime sludge from the SCU.

Overall, this piece of equipment is the primary operational headache in the existing water plant. The plate press is not an automatic system. Plant personnel are required to start the sludge pump manually and provide full time in person operation of the press. The pumped solids pass through a series of filters in the press unit. Plant personnel then have to manually separate the press plates, scrape off the collected solids on to the conveyor and push the press plates back together. Given the current operation; 3-4 days a week plant personnel have to operate this equipment for most of a workday. In addition, the conveyor simply carries the lime solids to a waiting dump truck that must be unloaded regularly offsite. Currently, staff are storing lime solids at the wastewater treatment plant site on the other side of town.

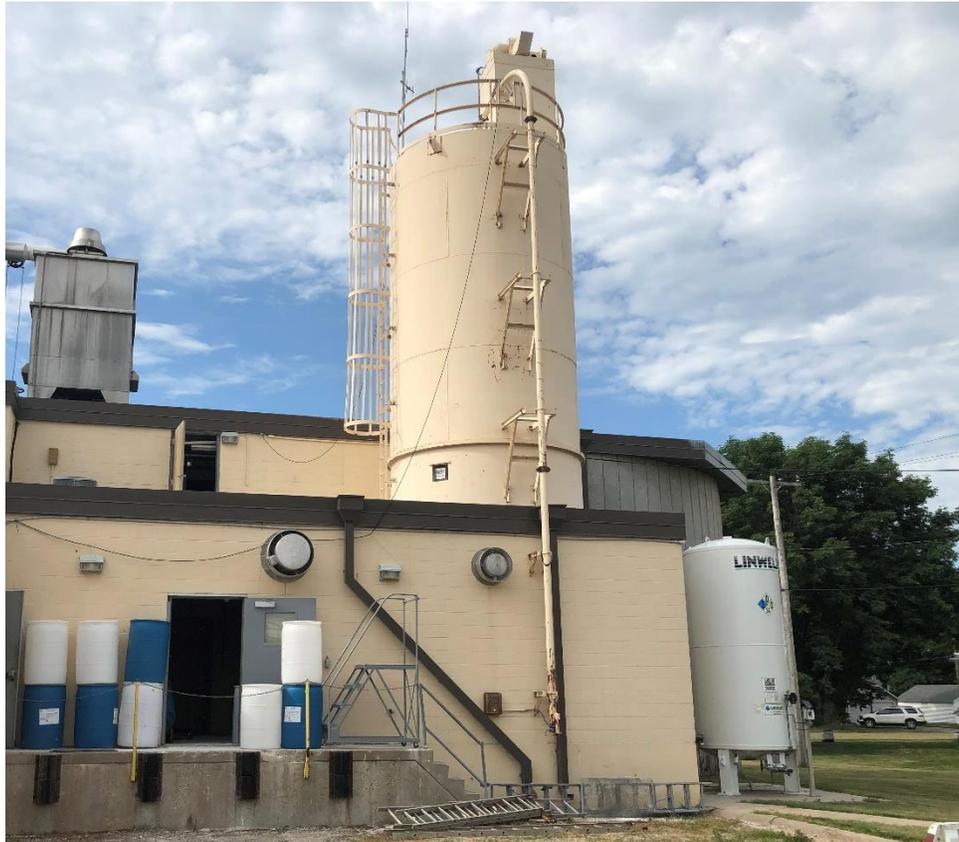
The existing lime silo is 12' in diameter and 18' tall with a truncated bottom cone. With the bottom cone, the total volume is approximately 3,475 cubic feet. A dust collector/bag shaker is installed on the top of the silo for vent filtering. The bag filter shakes the collected particles loose automatically. The system experiences excessive "dusting" during filling operations, which is wasted product and can lead to upset neighbors around the WTP. The "dusting" that has been occurring during the filling process is the result of hydrated lime escaping through a pressure relief hatch on the top of the unit, which is an indication that the silo is being pressurized during filling operations. The silo is likely pressuring due to a non-functioning bin vent/dust collector. It is recommended that the city inspect the equipment and verify that all equipment is functioning properly. It may be necessary to replace the bin vent/dust collector.

The truncated bottom cone had an attached vibrator; however, it was not operational and replaced with a compressed air system which is intended to stop "bridging" in the lime silo. However, staff report the system does not work and bridging is currently being resolved by simply hitting the cone with a mallet. The overall structural condition of the silo appears sound, however, much of the ancillary items (compressed air system, dust filters, process controls) are in poor condition.

Figure 2-18: Hydrated Lime Silo presents a photo of the existing lime silo and exterior appurtenances.

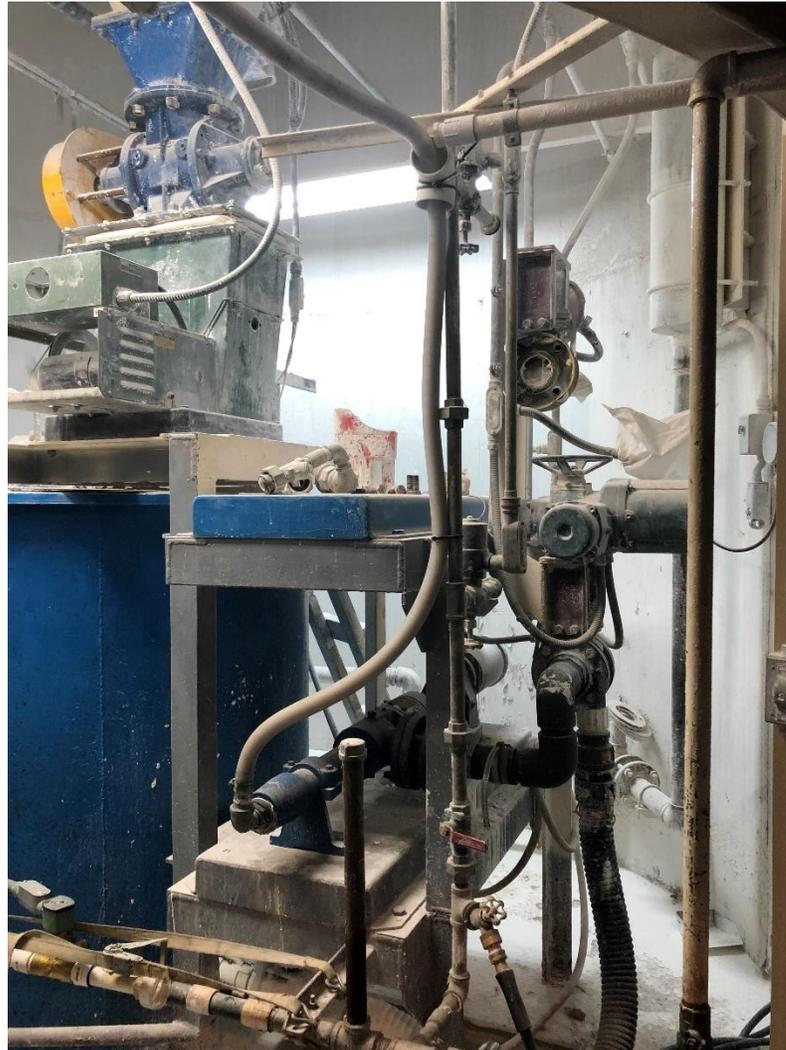
Figure 2-19: Hydrated Lime Interior

Normal operation is for the bulk hydrated lime to be fed into a slaker through the truncated cone and a volumetric feeder. Water is added and the lime is mixed to create a lime slurry. This slurry is pumped into the mixing zone of the solids contact unit. **Figure 2-19: Hydrated Lime Interior** presents a photo of the existing lime interior apparatuses.

The overall condition of the lime slaker, mixing tank, and pumping system is poor. The system has issues with plugging of the volumetric feeder, frequent failures of the mixing system, slurry pump failures, and overall unreliability of the unit. In addition, actual feed rates of the lime are difficult to control and true product measurement into the SCU is not able to be determined. Operations staff typically have to learn what works by trial and error and true process control is not possible. Given the age and condition of this system, complete replacement is required.

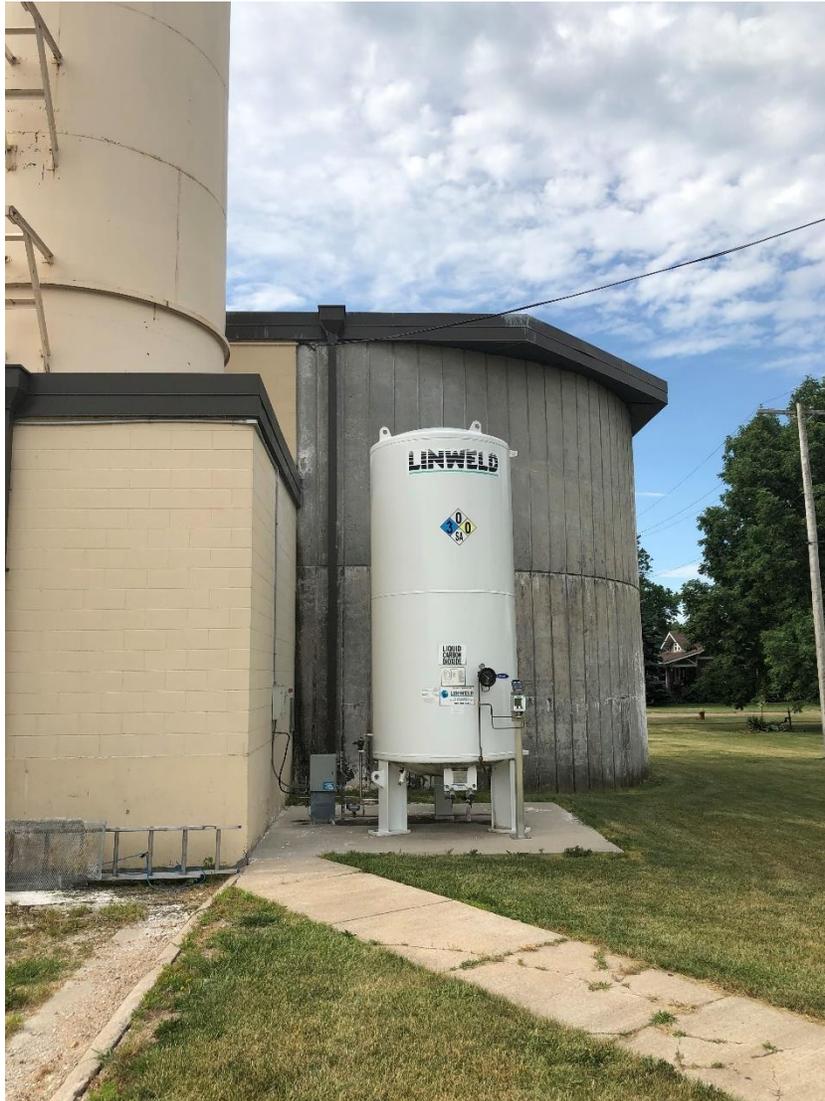
Figure 2-20: Bulk Carbon Dioxide Storage Tank

The carbon dioxide gas feed system is sourced from a rented bulk storage tank, then injected via diffuser in the recarbonation basin. Per the WTP O&M Manual, an estimated 34 lbs/hour feed rate was used. A 1 HP Lightnin mixer is used to mix the basin. This mixer was last replaced in 2010 and is good condition.

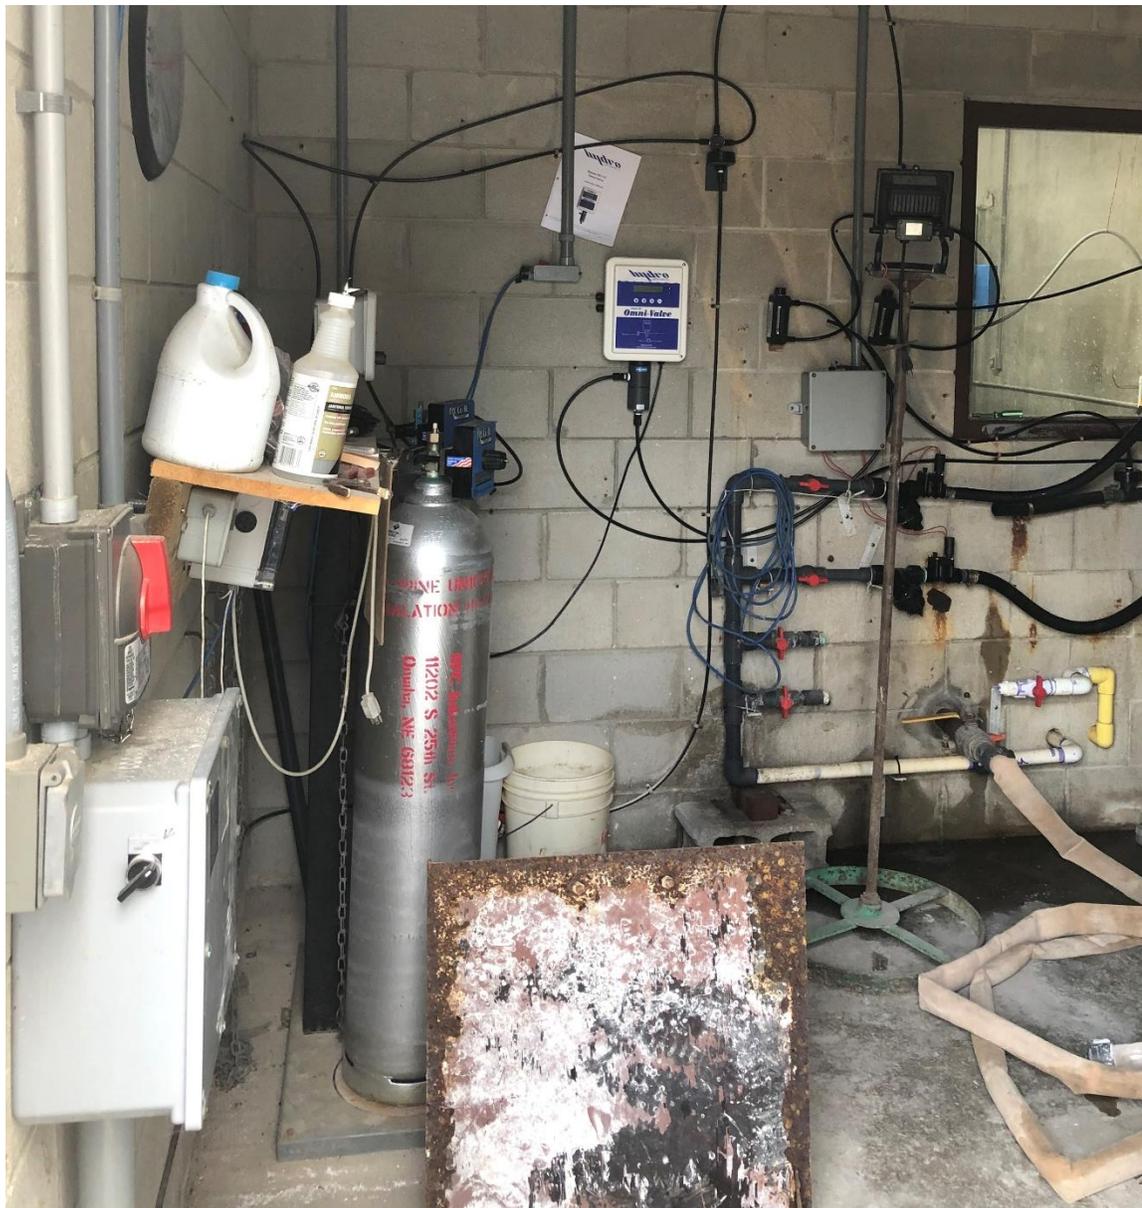
Figure 2-21: Gas Chlorine Feed System presents a photo which includes the Hydro® feeder, gas chlorinators, and the 150-lb gas cylinders sitting on scales. Based on conversations with the water treatment plant operator, the gas chlorine feed system is believed to be in average working condition. However, the necessary solenoid valves, injectors, and overall layout of the chlorine system is in poor condition. Given the mismatched nature of the system, age of some equipment, and lack of true control of dosing rates, it is recommended to upgrade and replace much of the chlorine feed system.

As noted, the chlorine is injected after the filters, prior to the water entering the clearwell. Though the benefit of chlorine being inject here is increased chlorine contact time, there is no regulation or general requirement to do this. However, as noted in a recent clearwell inspection report, the concrete clearwell roof has areas with exposed rebar and spalling concrete. It is the opinion of this report that the presence of chlorine in the clearwell is contributing to this deterioration. Chlorine naturally dissipates from water over time and the open air headspace above the waterline in the clearwell is likely to have varying levels of chlorine gas present. This chlorine gas can recombine with moisture present on the interior roof surface and create hypochlorous acid which can react with calcium in the concrete causing spalling.

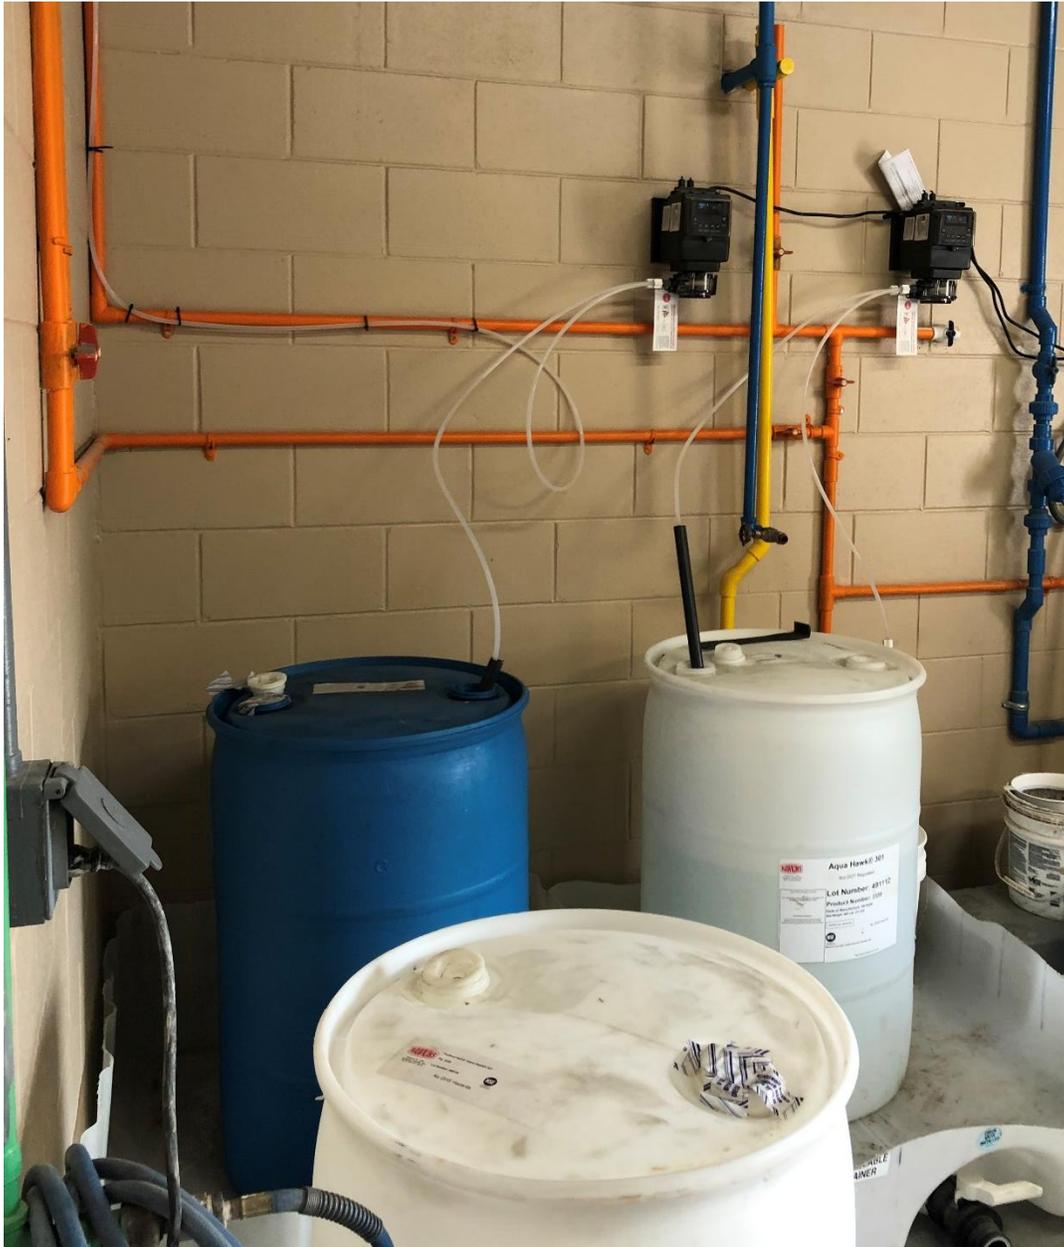
Figure 2-22: Polymer Feed System

If the polymer system is to be continued, a replacement system is recommended. Installing a neat polymer mixing and dosing system would allow the city to use neat polymer and eliminate the need to mix and/or dilute dry or bulk liquid polymer.

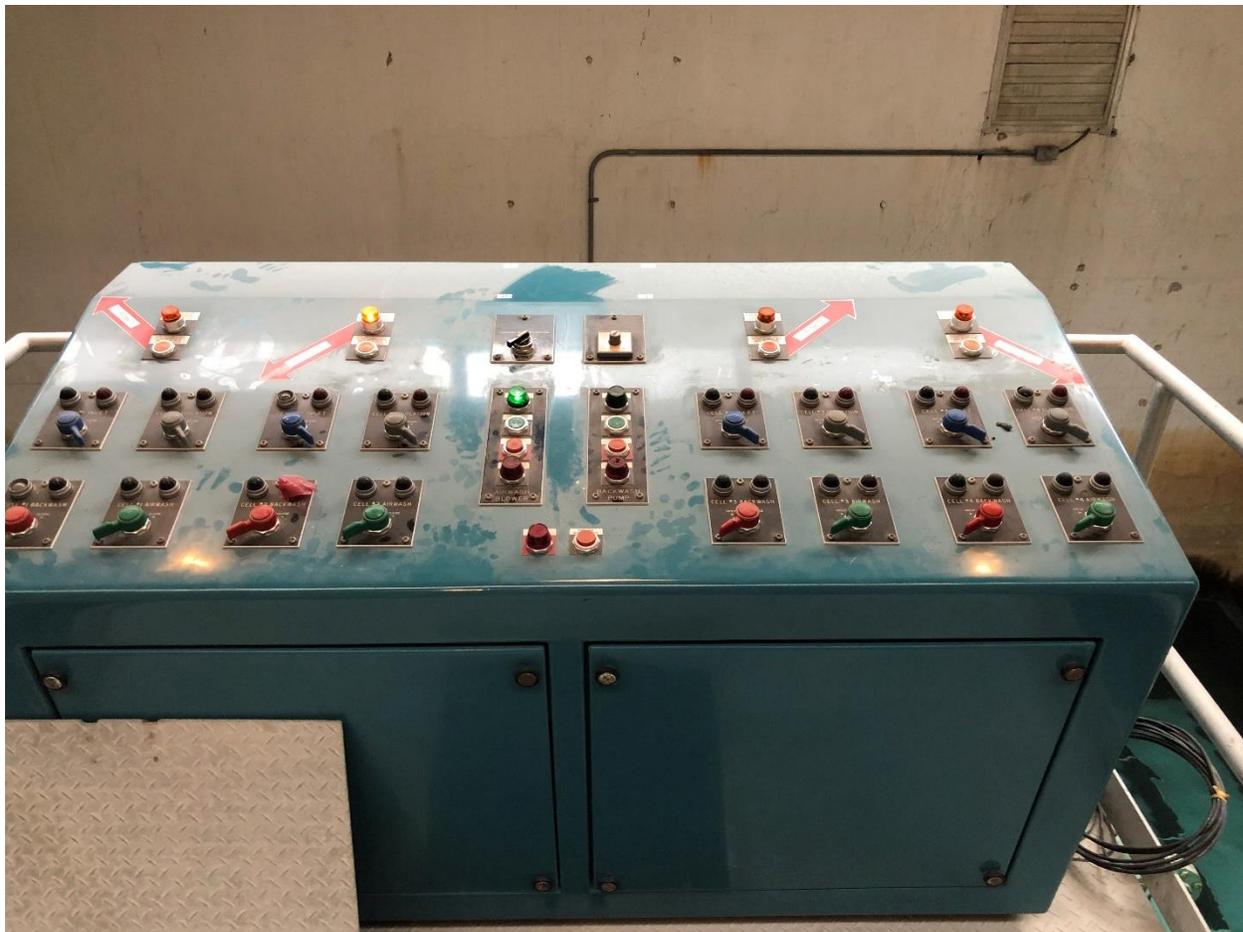
Figure 2-23: Current Filter Control Panel

Overall, a complete rehabilitation of the control system is warranted to provide necessary operator control, remote management, and to reduce the burden on operational staff.

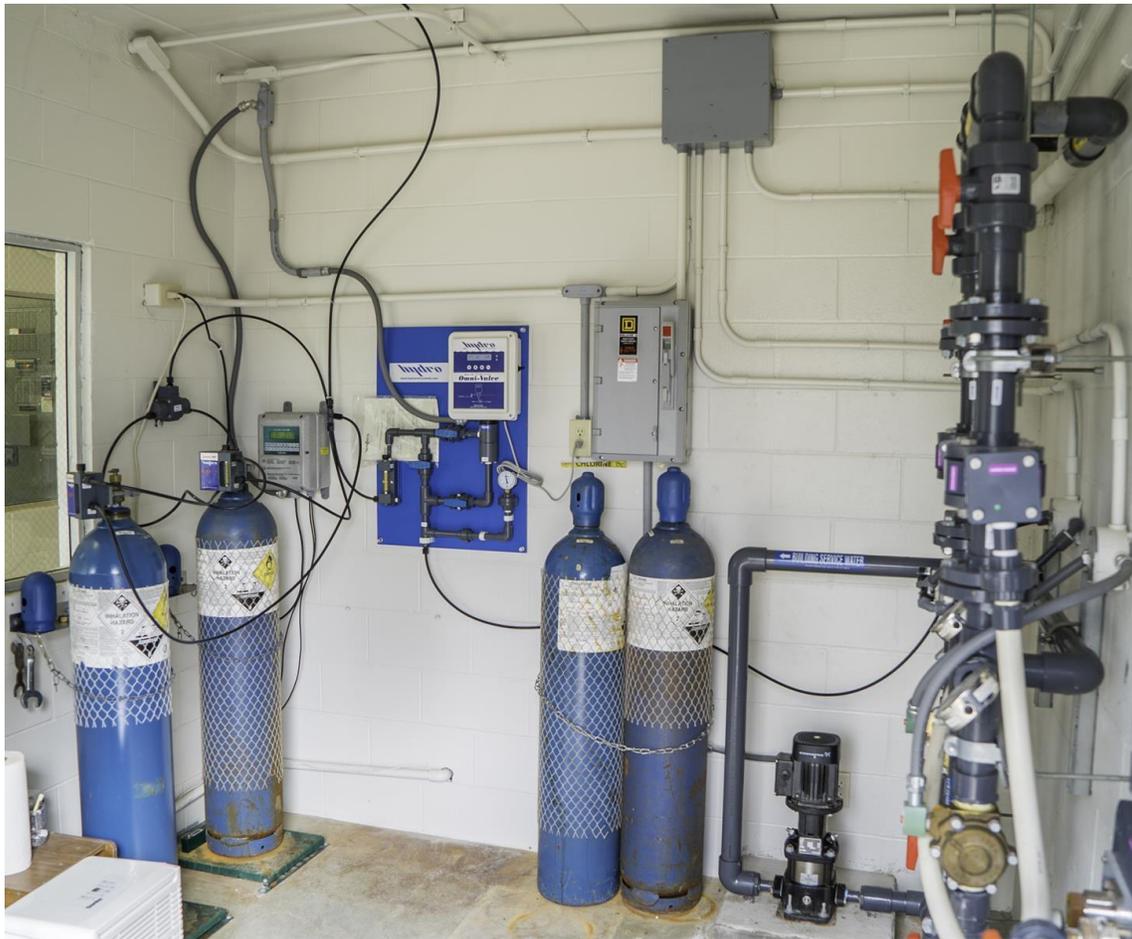
Figure 4-5: Example Chlorine and Carbon Dioxide Feed Room

The chlorine system is also proposed to be upgraded. It is recommended to relocate the existing chlorine injection points to a common injection point on the high service pump discharge piping to limit continued degradation of the existing concrete clearwell. With relocation of the chlorine injection points and the fact that the existing high service pumps are controlled via variable frequency drives (VFD's), it will also be necessary to update the controls to facilitate flow-paced injection based on the speed of the high service pump in-use. A booster pump will also be needed to increase the pressure of the chlorine chemical. The following figure illustrates what the upgraded chemical feed room may look like.

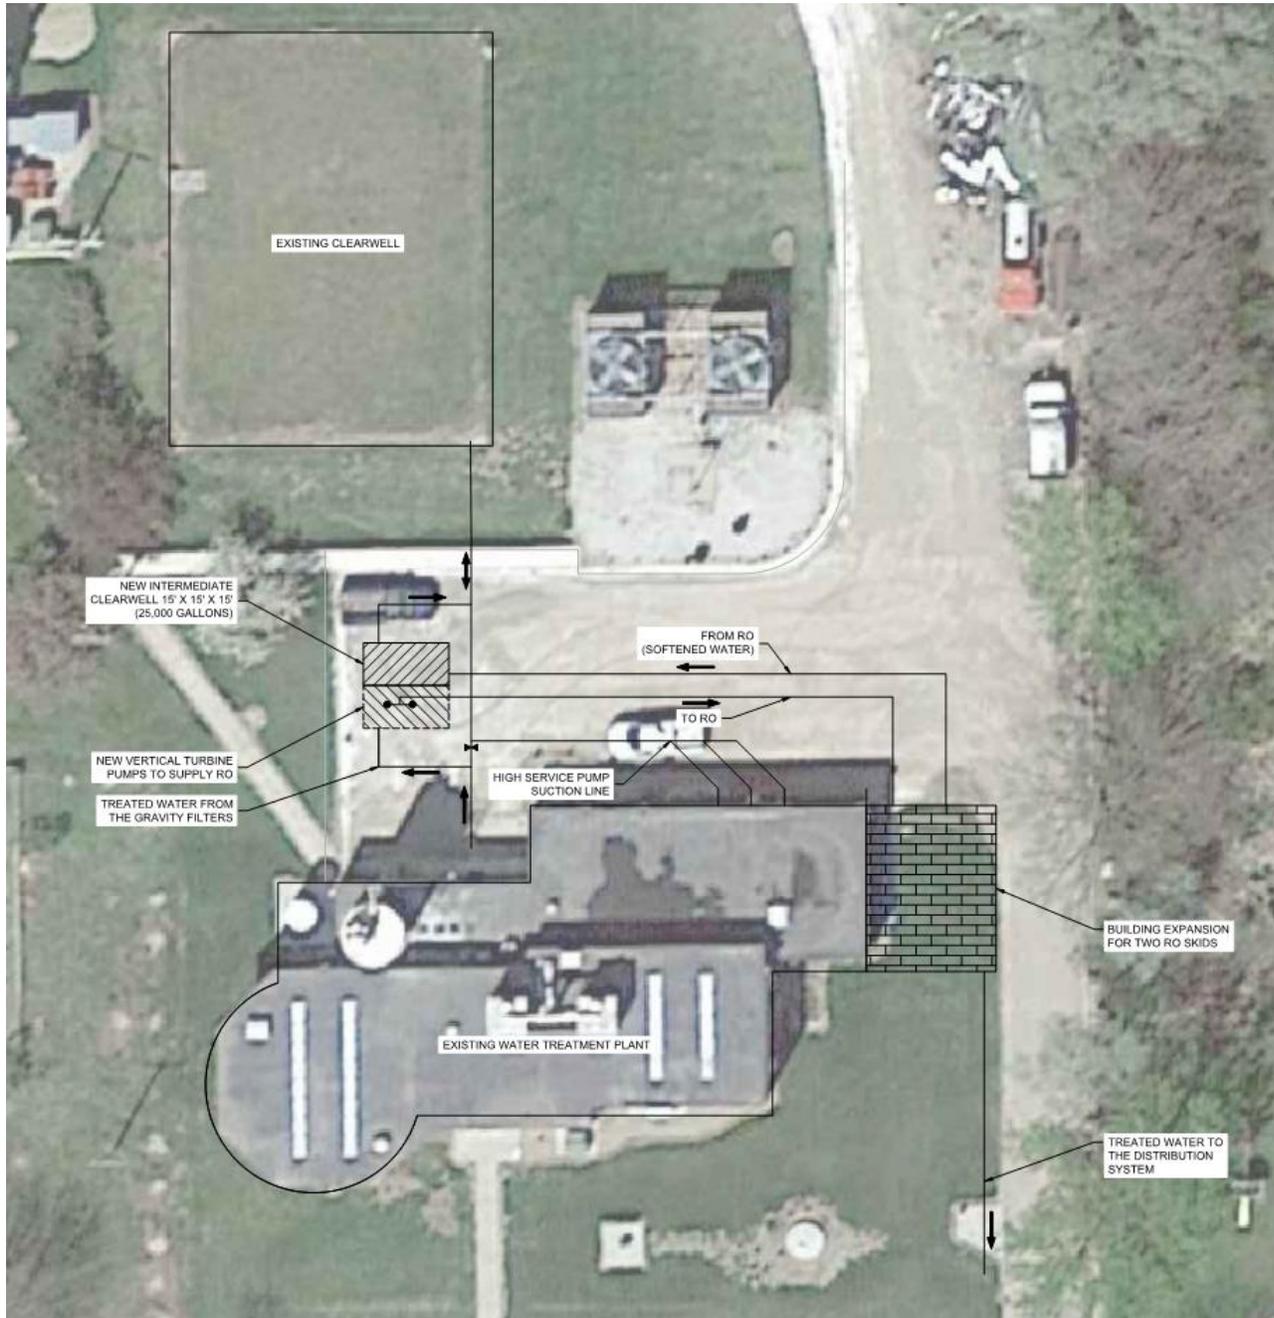
Figure 4-7: Alternative 2 RO and Clearwell Schematic

A new 25,000 gallon intermediate clearwell will need to be constructed as shown in the figure. The concrete basin will consist of two chambers separated by a permanent wall with a weir. Normal operation would have all treated water from the filters flow into the influent side of the clearwell. One of two vertical turbine pumps would then pump the required flow to the RO systems while allowing the remaining unsoftened water to pass over the weir wall into the effluent side of the clearwell. Treated water from the RO units will flow back to the effluent side of the clearwell to provide the blended final product. The high service pumps will draw the final product from the existing clearwell and pump into the distribution system. Continuous monitoring equipment will measure and adjust the RO system and blend rate to maintain the desired hardness level in the water sent to the city. The clearwell will have a small block building directly over it to house the pumps, valves, piping, and monitoring equipment.
